**U.S. ENVIRONMENTAL PROTECTION AGENCY
POLLUTION/SITUATION REPORT
2015 Gold King Mine Release SITREP**

Subject: SITREP #4
Gold King Mine Release

San Juan County, Colorado
Latitude: 37.8945 Longitude: -107.6384

From: R8 IMT Situation Unit
Date: 08/12/2015
Reporting Period: 08/11/15 through 08/11/15
Website: epa.gov/goldkingmine

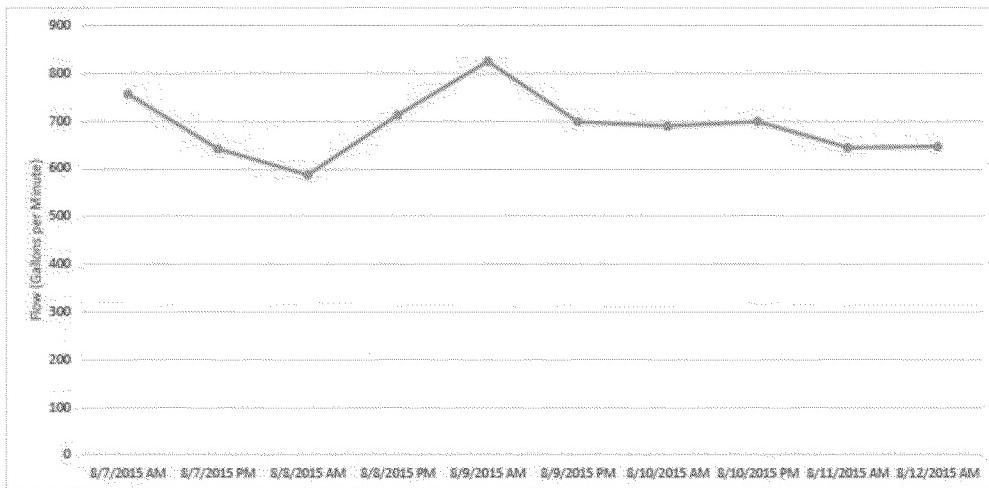
The EPA continues to operate four treatment and sedimentation ponds at the mine site which are treating water by lowering acidity levels and removing dissolved metals. Flow from the mine through the morning of 8/12/2015 is shown in the following chart.

Treated water from the last treatment pond is discharging into Cement Creek at levels cleaner (higher pH and lower levels of metals) than pre-event, background conditions in the creek. Over the next several days, the EPA will make upgrades to the system to ensure its continued operation. Flow data out of the mine is being collected manually two times per day. Water quality data is being collected at the influent and effluent of the treatment
